Hanson Inspections

Your Property Inspection Report

123 Anywhere Lane, Your City, AB, M4U 1R4

Date of Inspection: 2018/4/12 Time: 9:00 AM
Age of Home: 2010 Size: 1483
Weather: Temperature approximately -4 degrees. Cloudy.
Order ID: 205

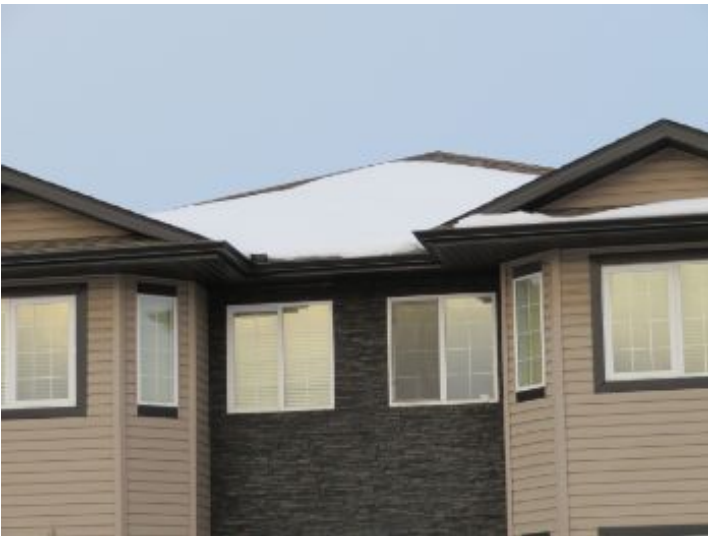
Snow/ice cover.

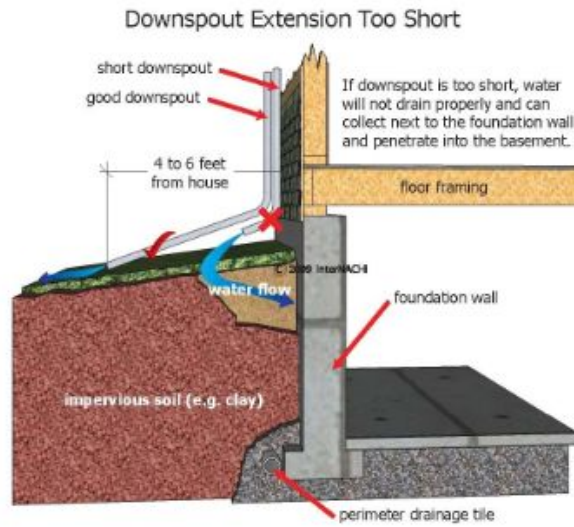
- This was a limited review from the ground only due to snow/ice cover.
- Downspout was noted to discharge water at foundation. I recommend ...

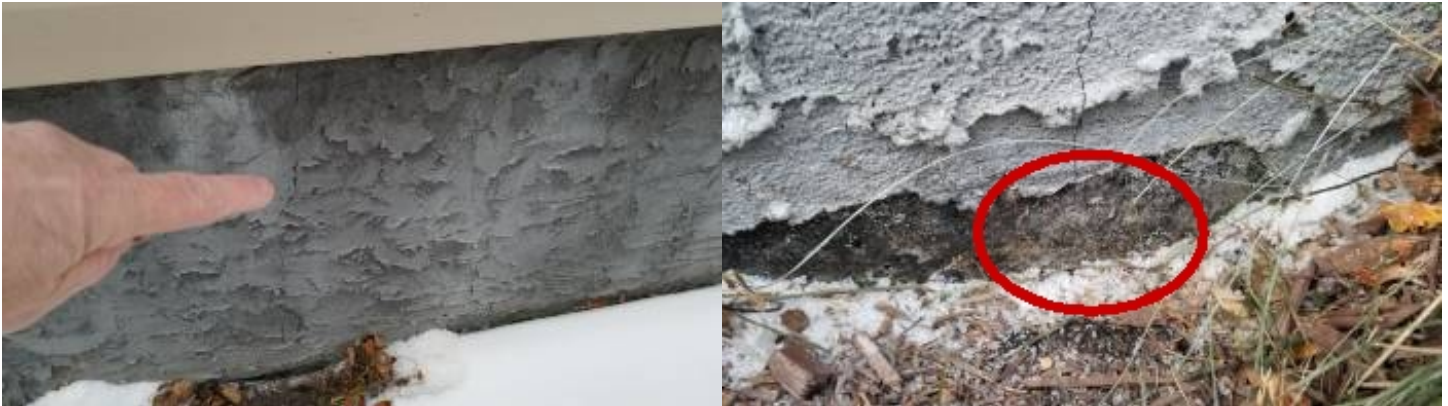
- This review includes the garage foundation.
- Minor cracking was noted in the parking material covering the foundation. This cracking appeared ...

Cracked parging.

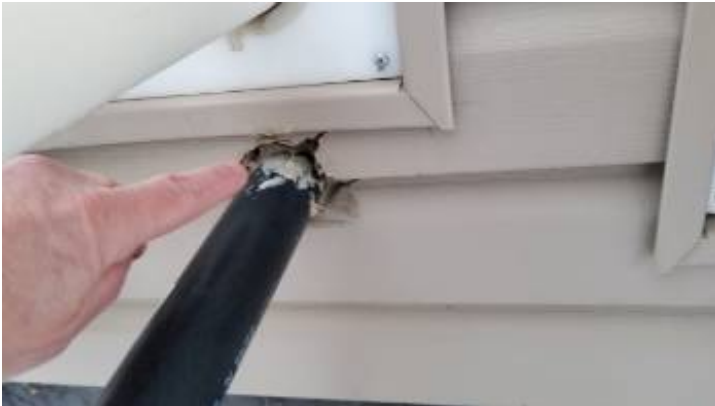
- **Unsealed through wall penetration(s) observed. This can allow ...**
- **Open seam/gap observed in siding material. This can allow ...**

Unsealed through-wall penetration.

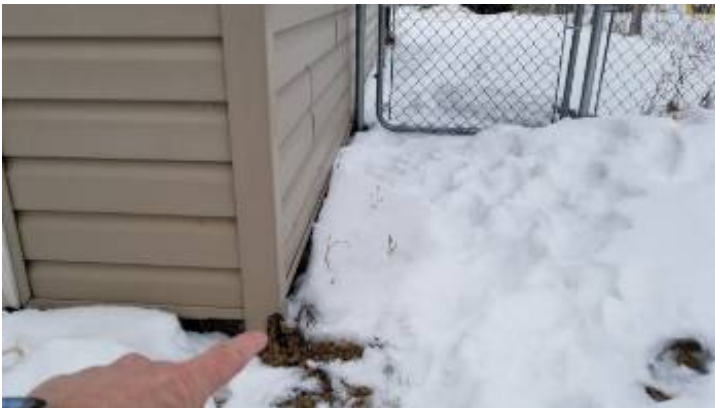
Damaged siding corner piece.

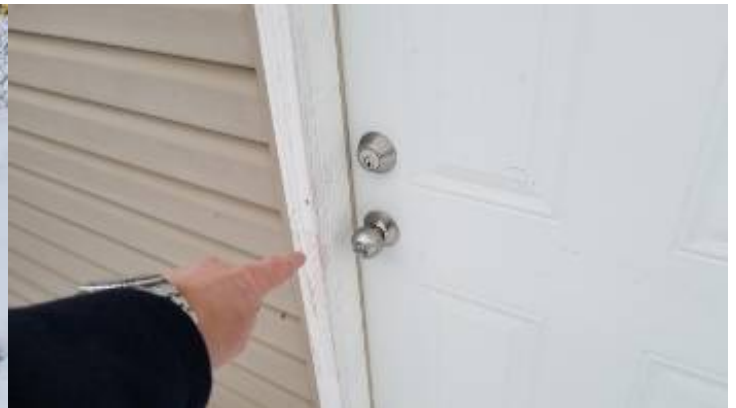
Peeling paint/stain.

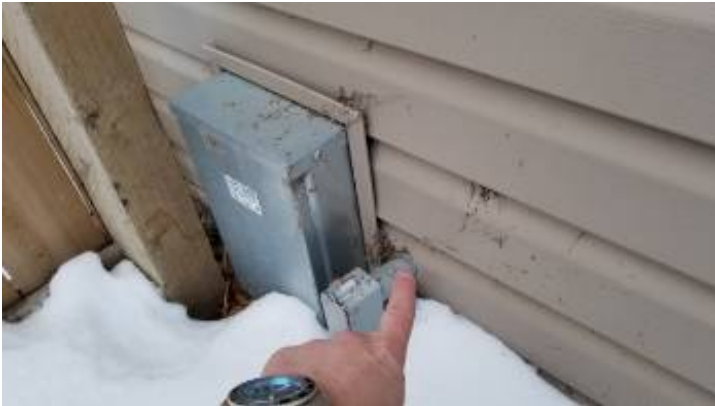
Unsealed through-wall penetration.

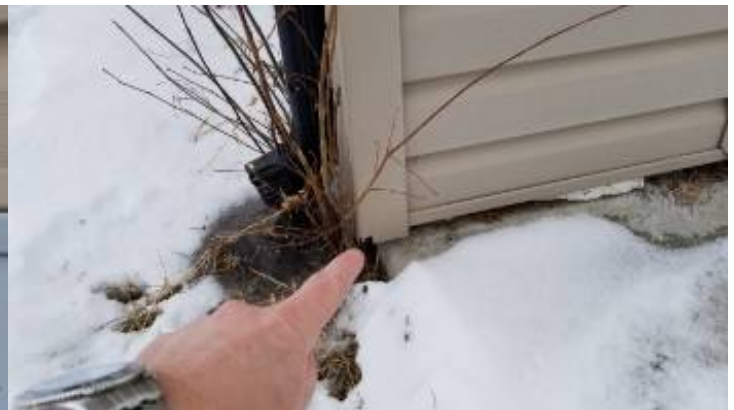
Damaged siding corner piece.

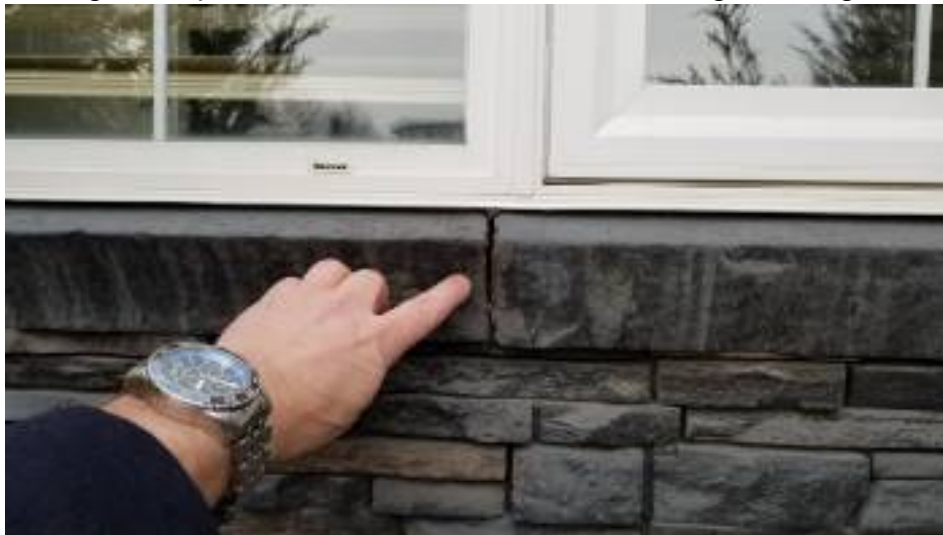
Open gap.

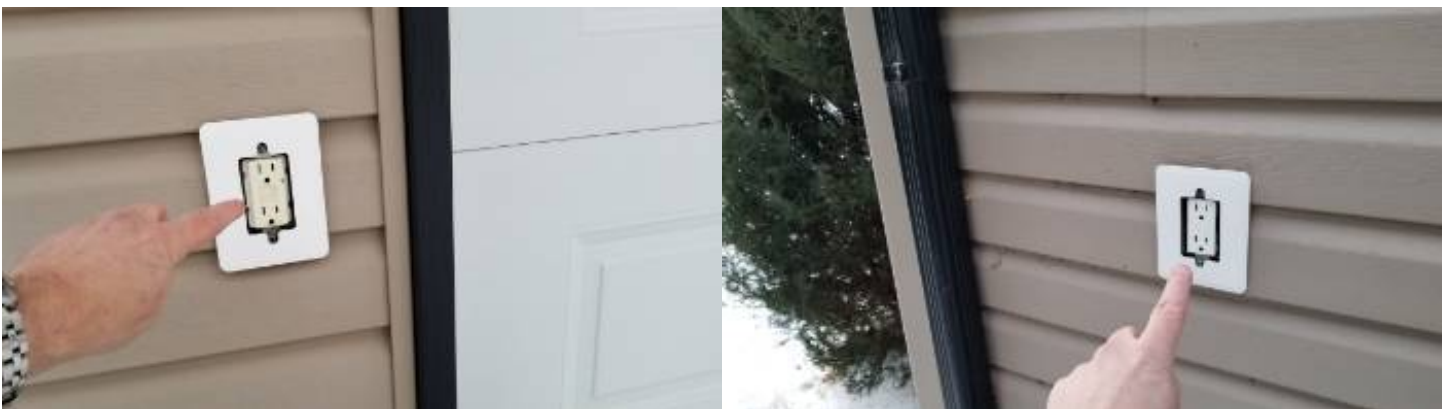
- The **GFCI** outlet at the rear of the house **also**...
- **OUTLETS:**
- **No cover plate or weatherproof cover on electrical outlet was observed on exterior outlet...**

No weather proof cover.

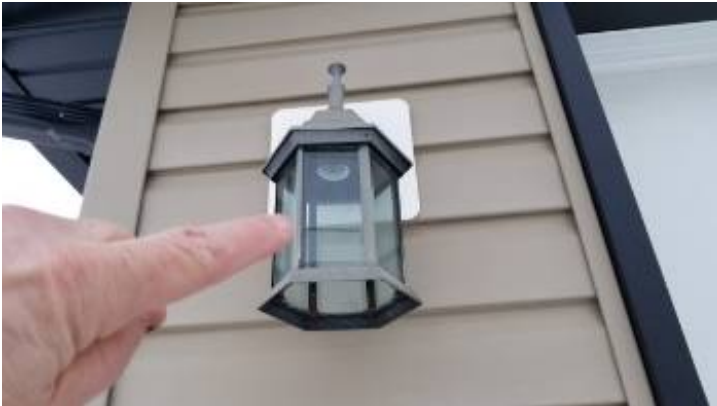
Missing light bulb.

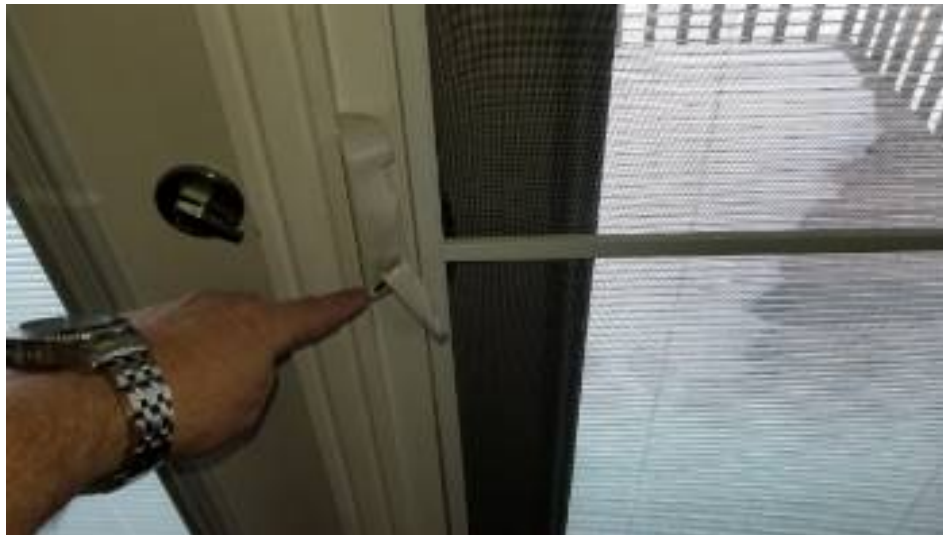
Loose hardware.

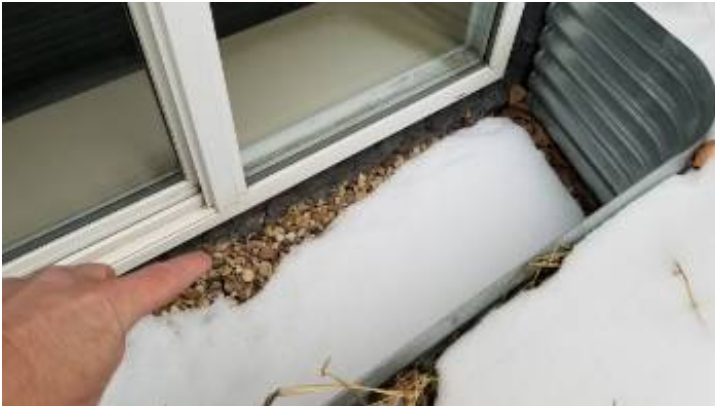
- Thermopane windows were observed in the home...
- WINDOW WELLS / EGRESS:
- Window in window well noted to be ...
- Maintenance Tip: Open window wells should have ...

Window too close to ground.

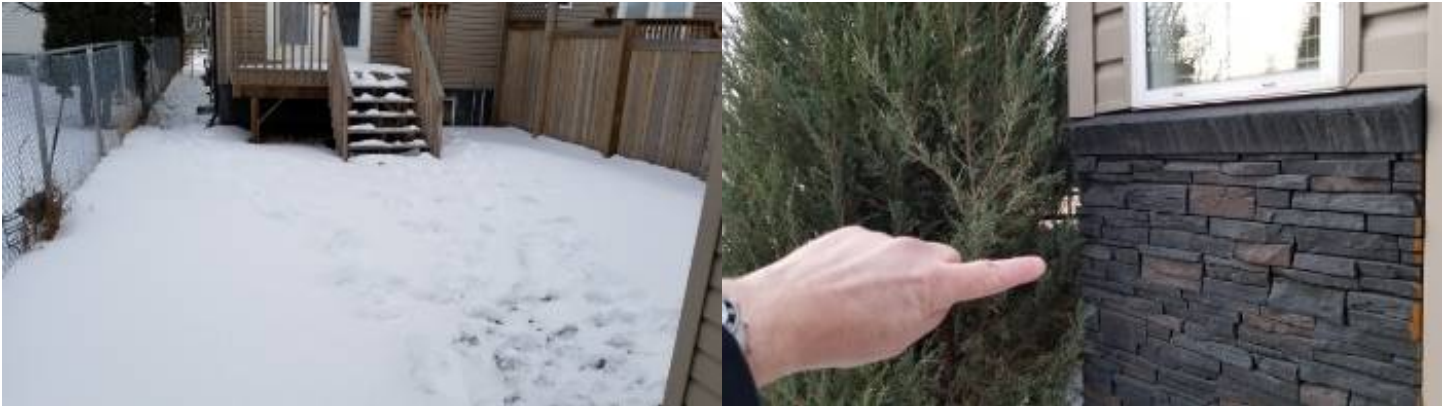
- GROUNDS:
- Trees/vegetation observed to be too close to the house/garage...
- FENCES:
- Limited inspection due to snow/ice cover.
- No major system safety or function concerns were observed.
- Wood was observed to be unsealed...
- Maintenance Tip: Clean and seal all exterior wood...
- Maintenance Tip: When landscaping...

Tree too close.

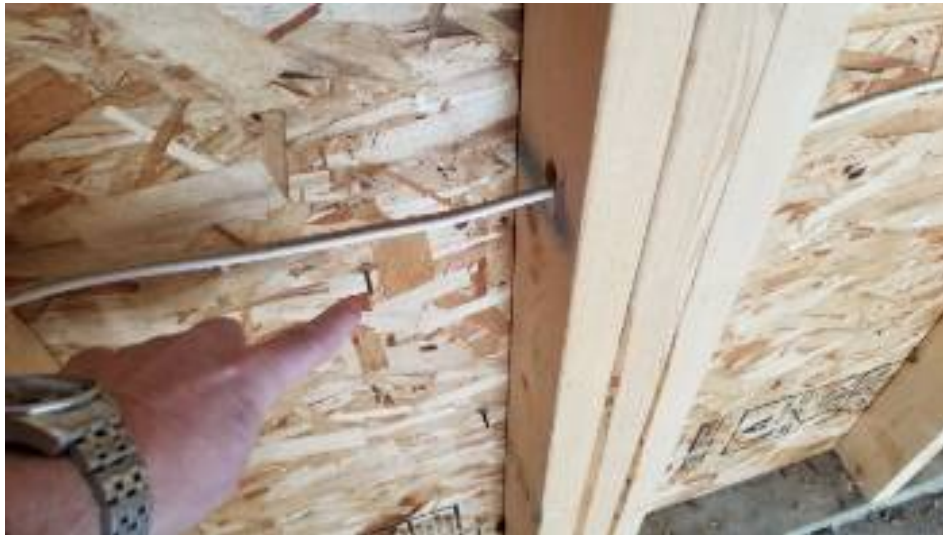
- No major system safety or function concerns were observed.
- **Sharp nail ends protruding...**

Sharp nails protruding.

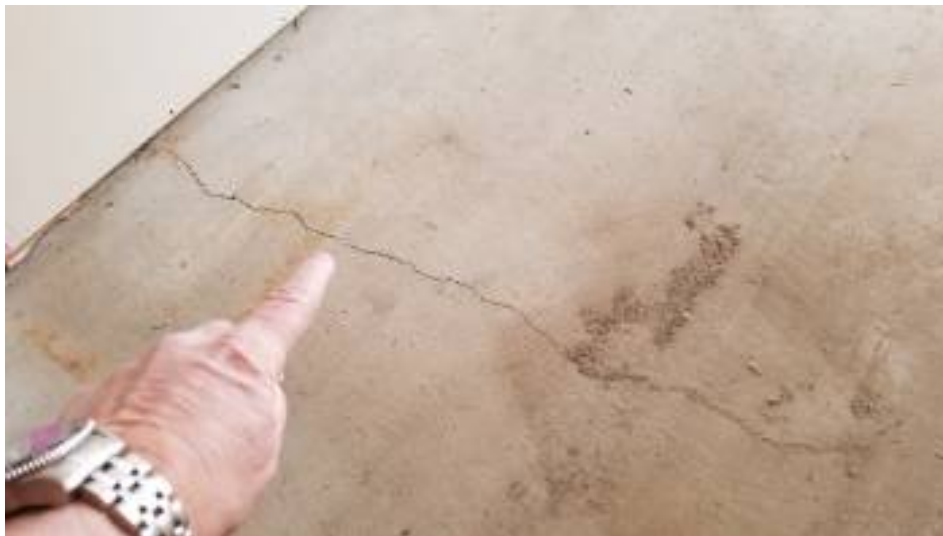
• Common cracks noted, which may leak at any time. This type of cracking is common and usually no reason for concern. Generally speaking, cracks that are less than 1/4" are not commonly regarded as being structurally significant. I recommend repairing the cracks and regularly monitoring for change. Consultation with qualified foundation contractor is recommended if the condition worsens or if water intrusion occurs.

Cracking noted.

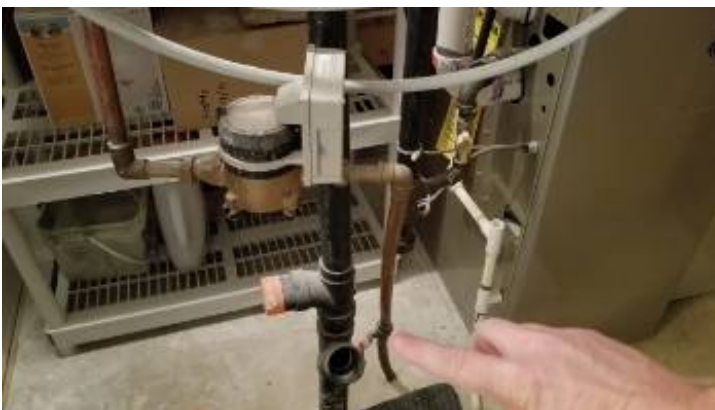
• **Open clean out on waste line...**

Open clean out/waste line.

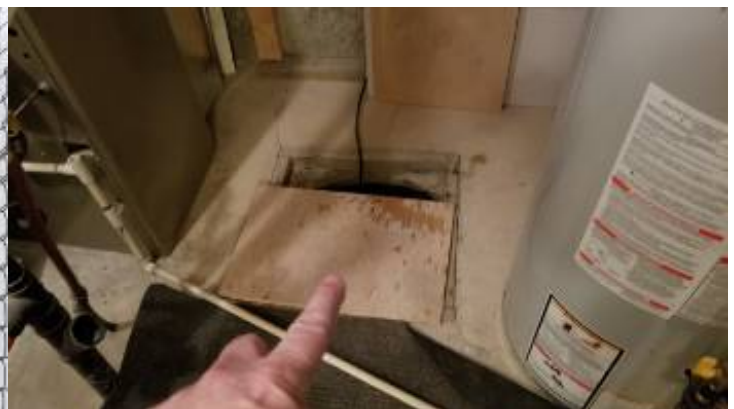
Missing cover.

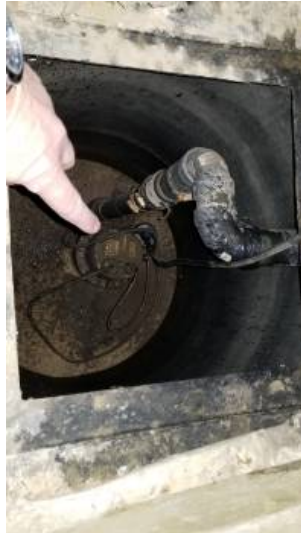
- **The sump pump tested inoperable...**
- **Sump pit cover was...**

Pump inoperable.

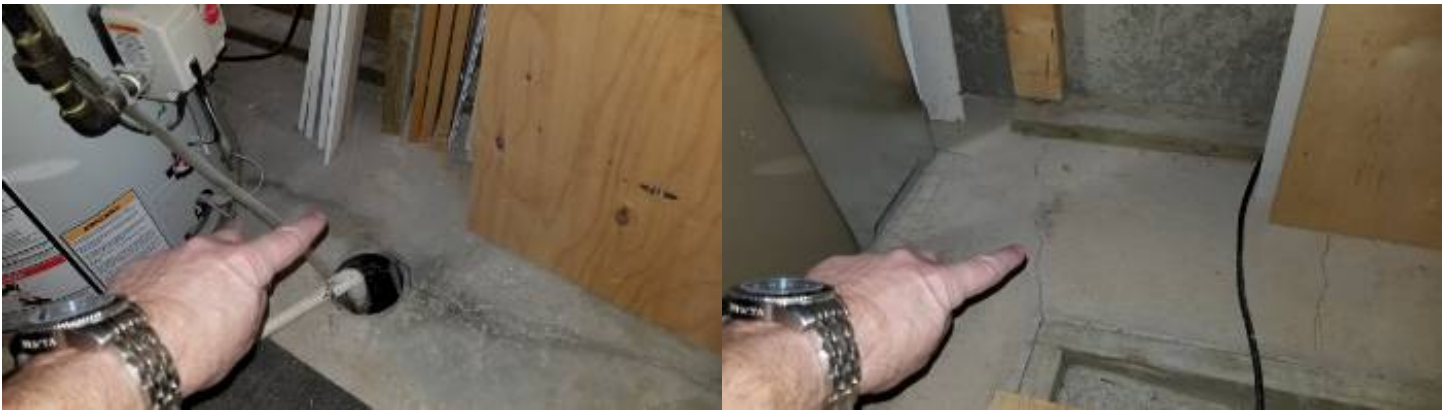
Cracking.

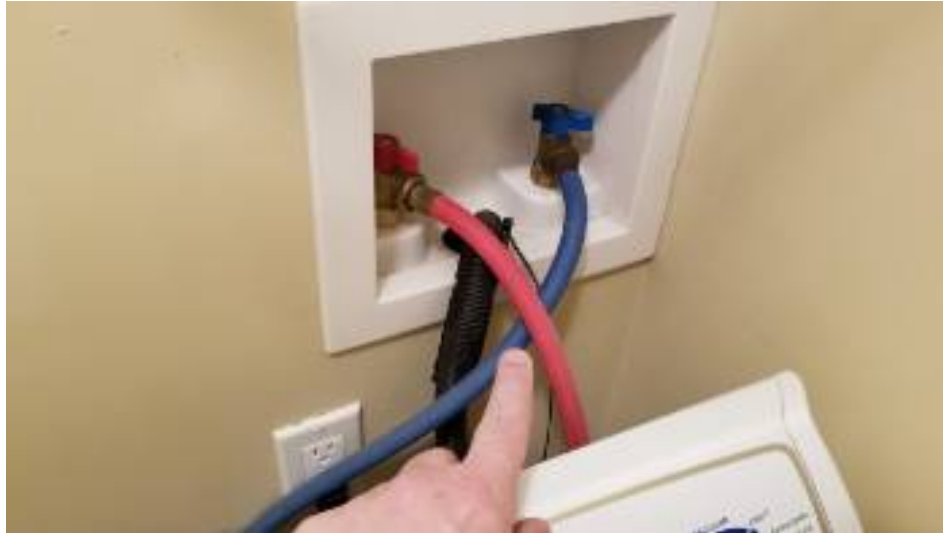
- Recommend upgrading the washer hook-up lines...
- Recommend installing a washing machine catch pan...
- No floor drain was...
- The drain stand trap...

Rubber supply hoses.

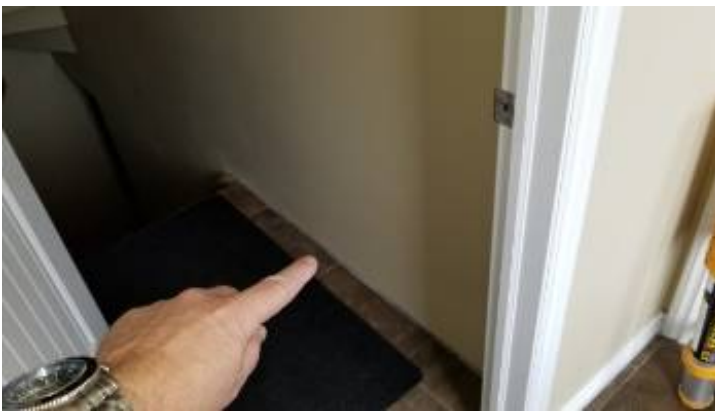
Missing baseboard.

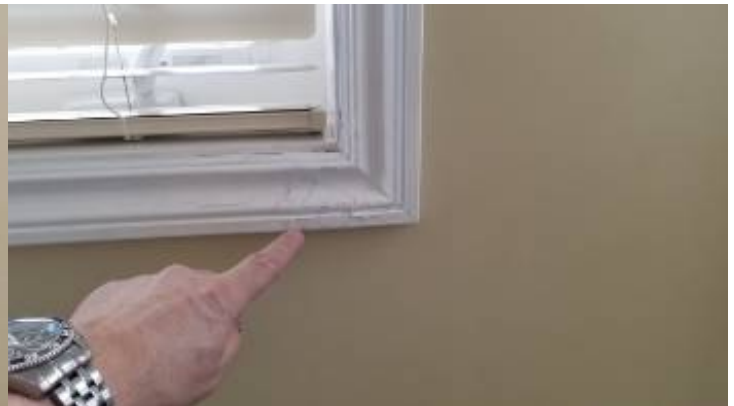
Evidence of previous leaking.

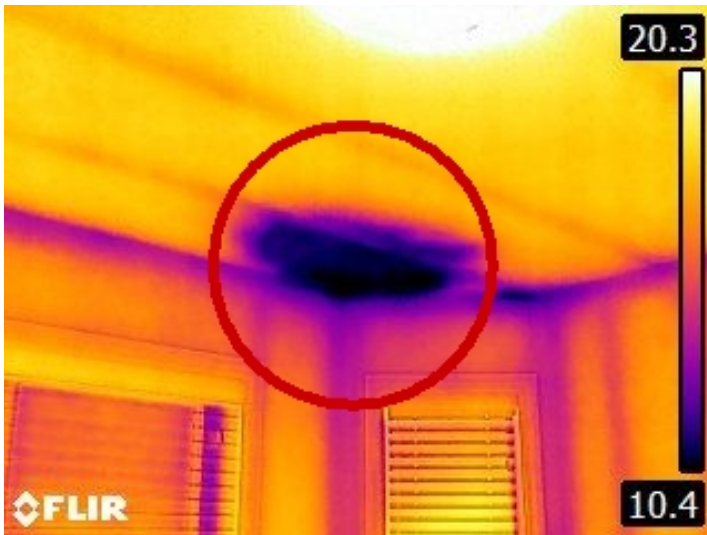
- CEILINGS/WALLS:
- Evidence of past/present water...
- Missing baseboard trim...
- The infrared thermal imaging scan indicated...
- Evidence of previous moisture intrusion...

Infrared anomaly in second (front) bedroom.

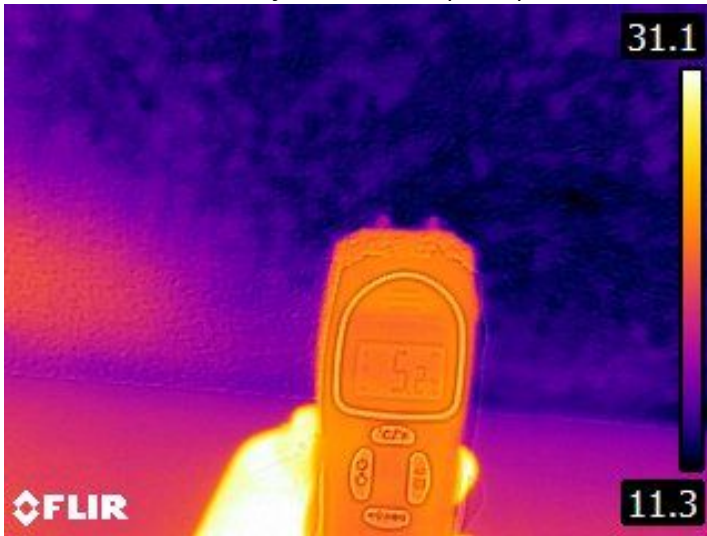
Anomaly showed slightly higher moisture reading.

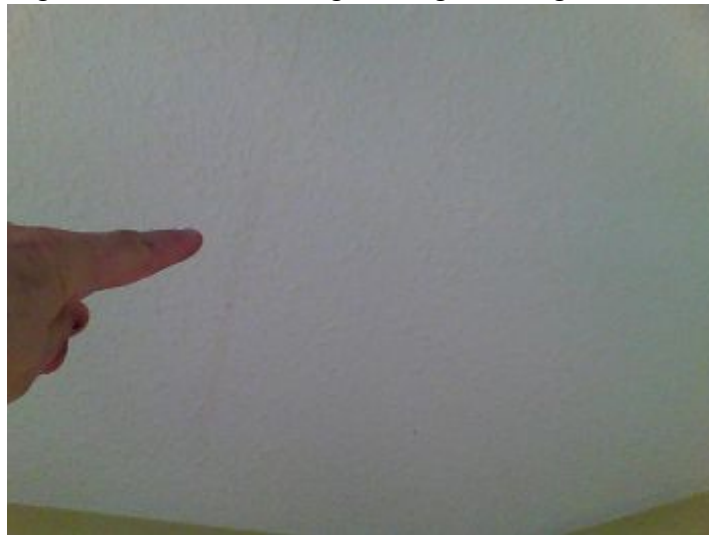
Staining at area of anomaly.

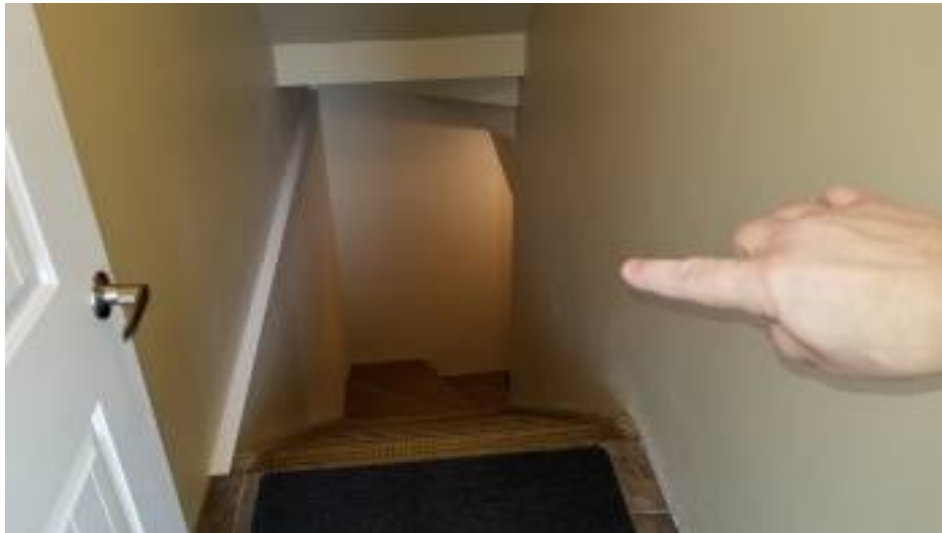
- **RAILINGS:**
- **Missing handrail observed....**

Missing handrail.

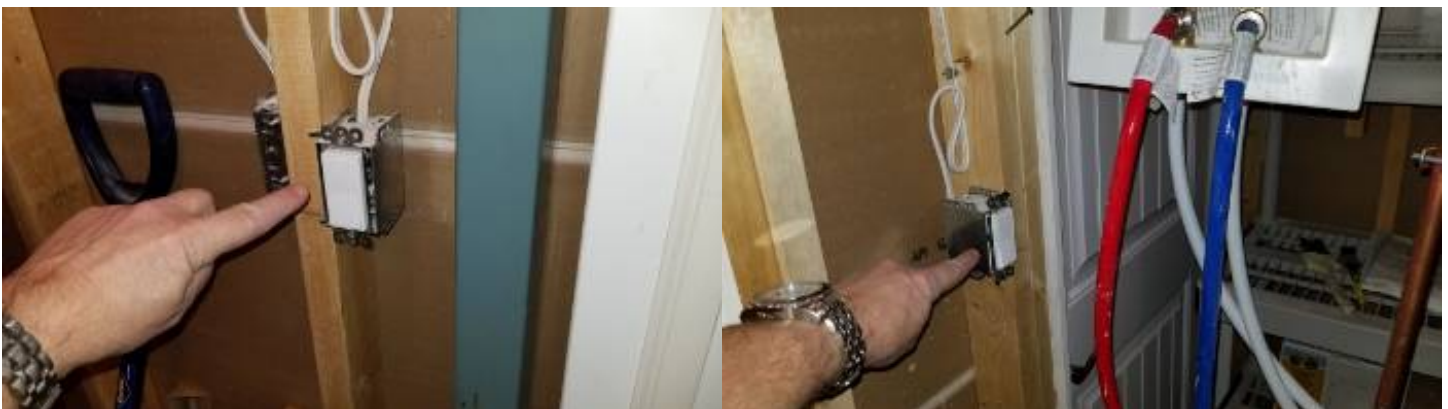
Missing cover plate.

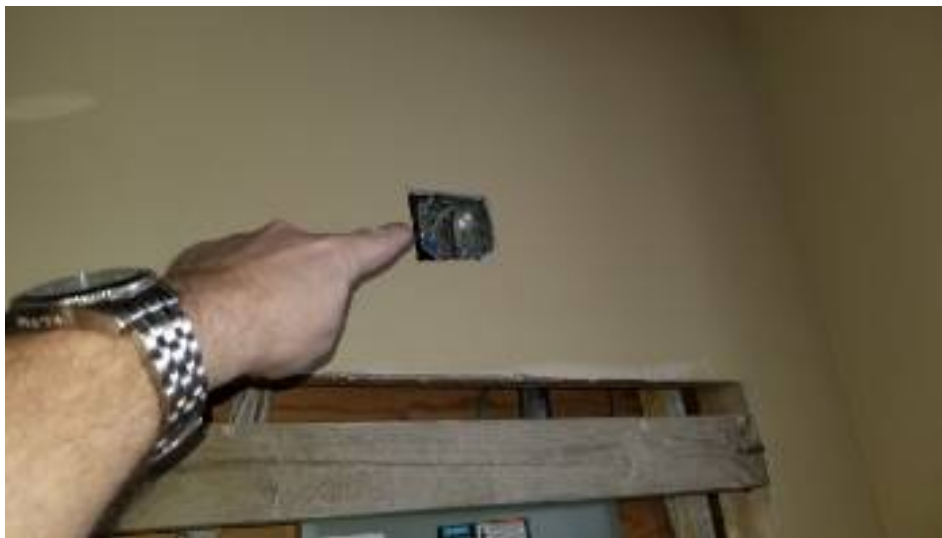
Missing fixture.

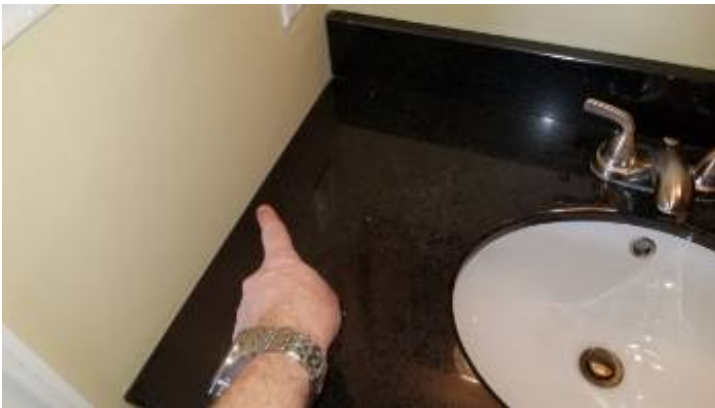
- Sink/cabinet base not sealed...
- Sink stopper observed to be...

Missing/insufficient caulk.

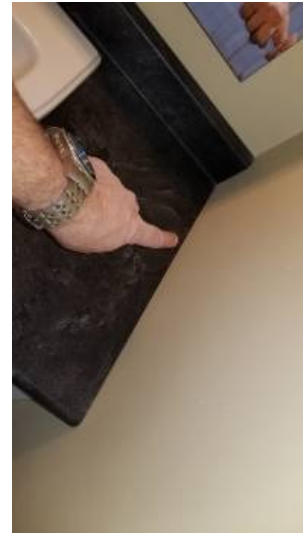
Missing/insufficient caulk.

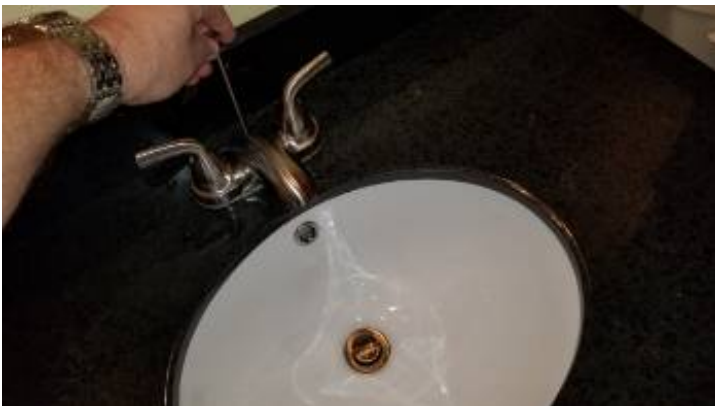
Inoperable stopper.

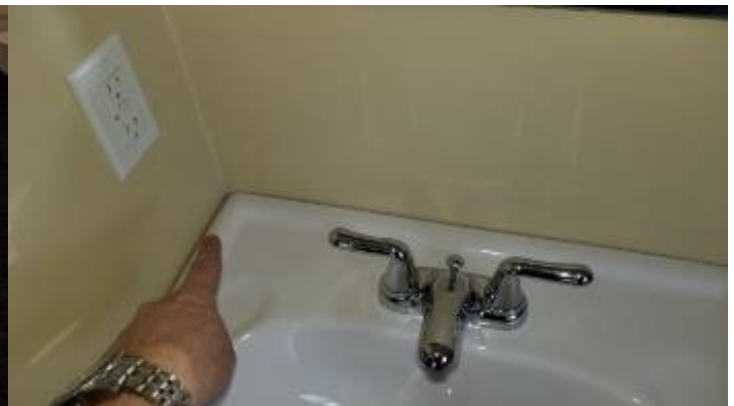
Missing/insufficient caulk.

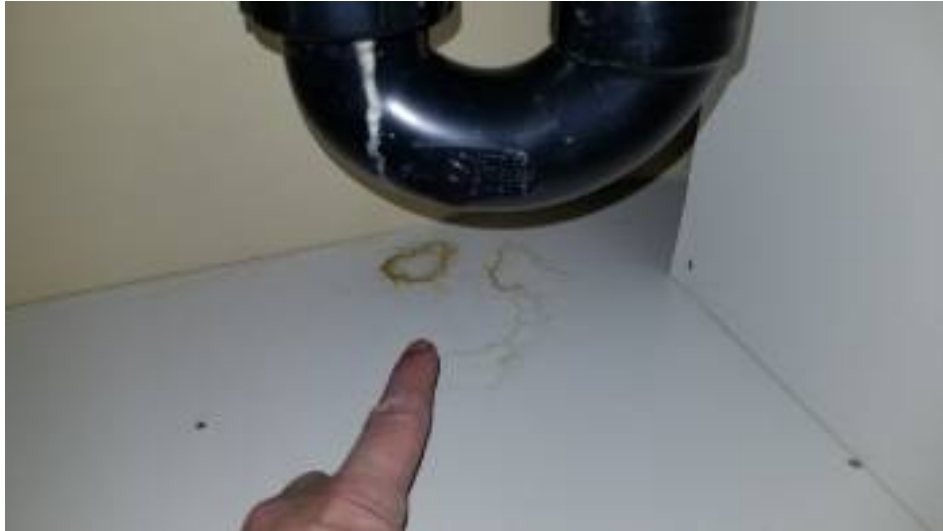
- Stains under sink noted...

Staining.

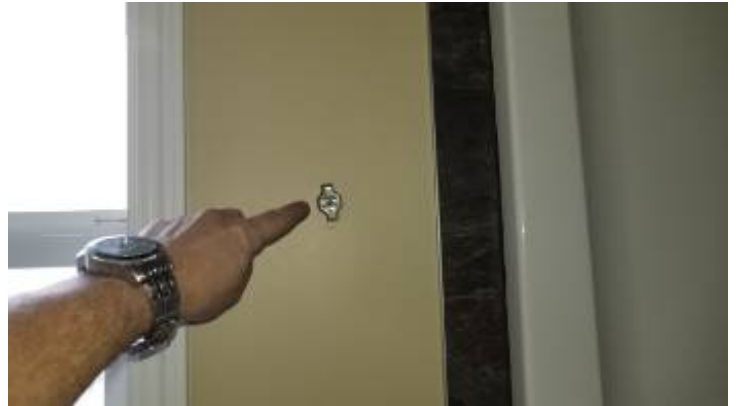
Missing towel holder.

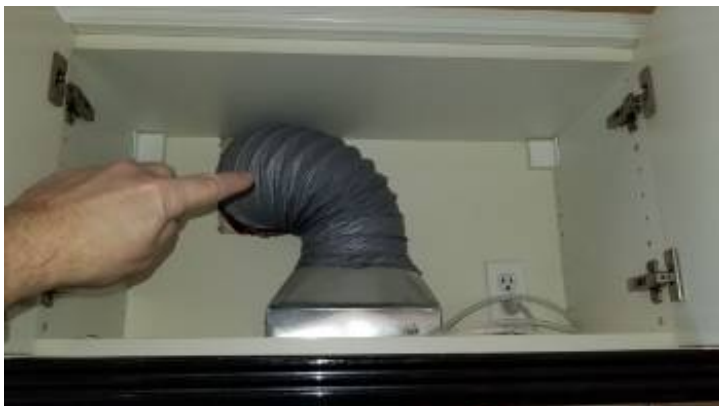
• Range hood was noted to be...

Plastic exhaust ducting.

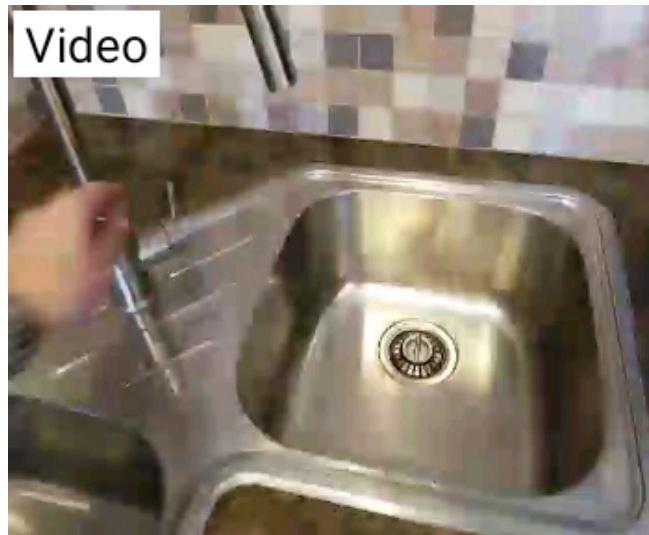
- The kitchen sink faucet was noted to be...

Irregular faucet installation.

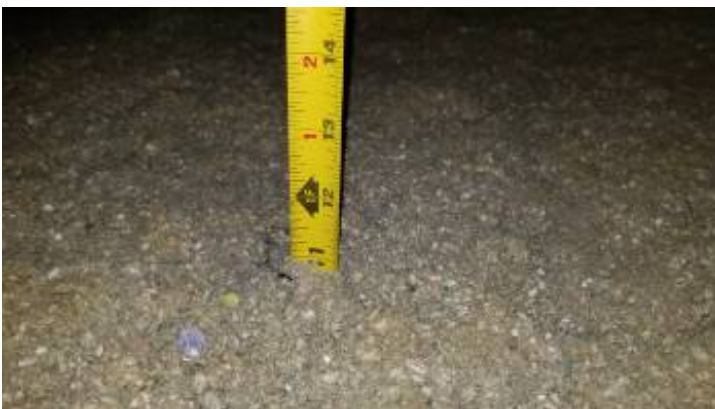
Uneven insulation coverage.

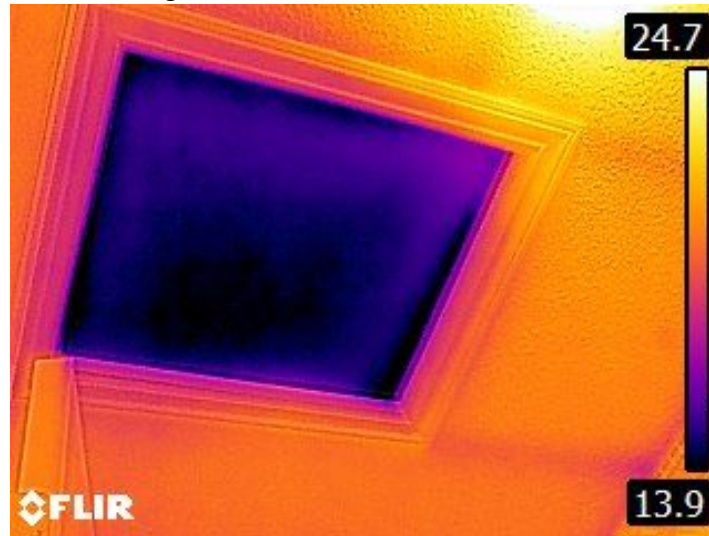
• Attic hatch cover/door was noted to be...

Hatch cover not insulated.
