Hanson Inspections

Your Property Inspection Report

123 Anywhere Lane, Your City, AB, M4U 1R4

Date of Inspection: 2018/4/12 Time: 9:00 AM
Age of Home: 2010 Size: 1483
Weather: Temperature approximately -4 degrees. Cloudy.
Order ID: 205

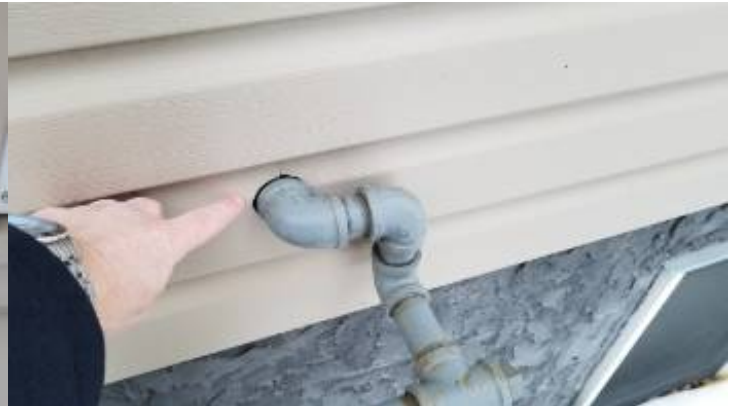
Unsealed through-wall penetration.

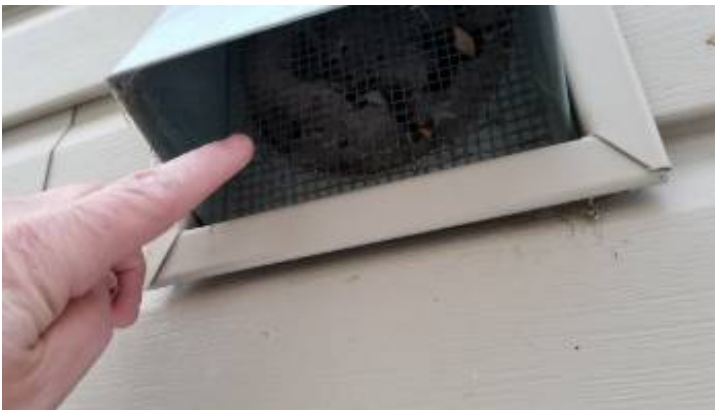
- Missing/improperly siding blocks at through-wall penetration(s) were observed. This can ...
- VENT CAPS:
 - Air intake vent for heater unit observed to be dirty/clogged.

Dirty/blocked air intake screen.

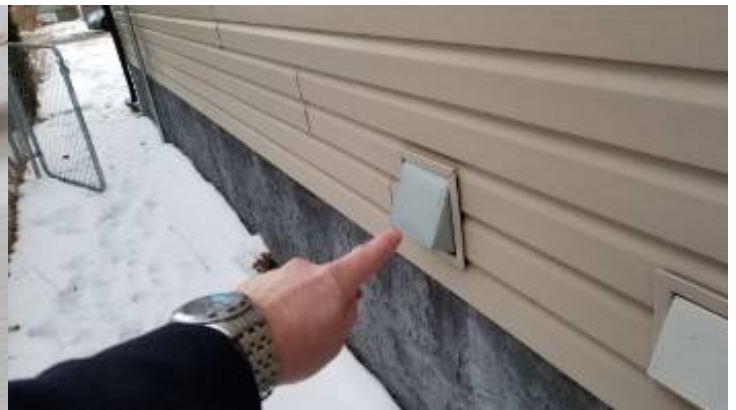
Dirty/blocked air intake screen.

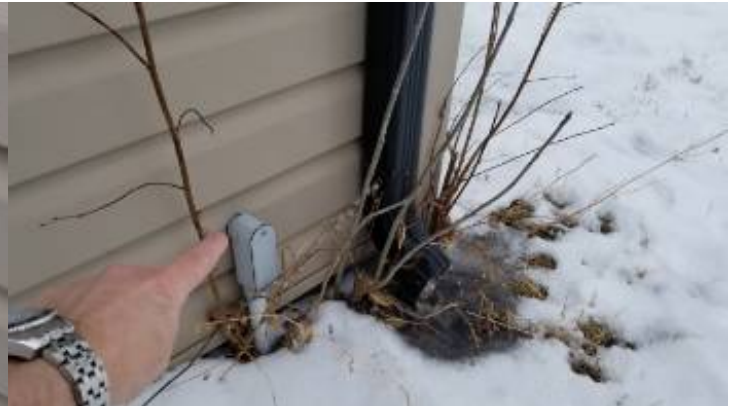
Unsealed through-wall penetration.

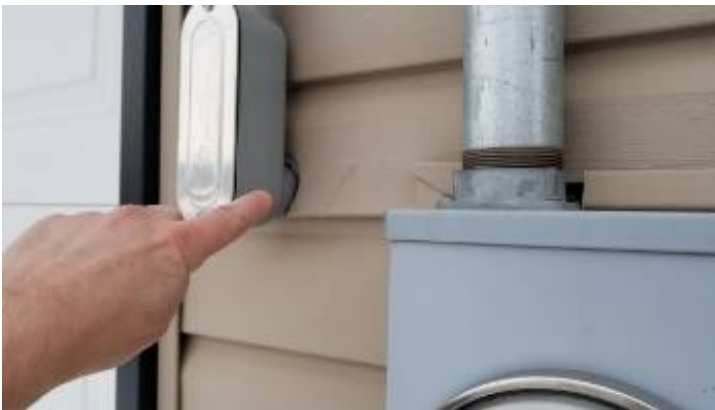
Unsealed through-wall penetration.

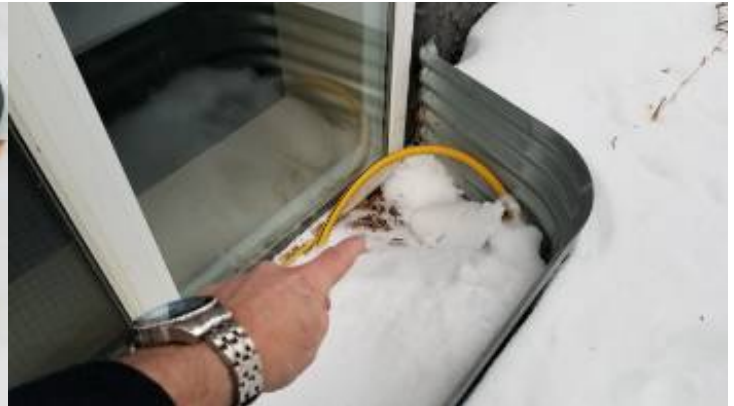
- Thermopane windows were observed in the home...
- WINDOW WELLS / EGRESS:
- Window in window well noted to be ...
- Maintenance Tip: Open window wells should have ...

Window too close to ground.

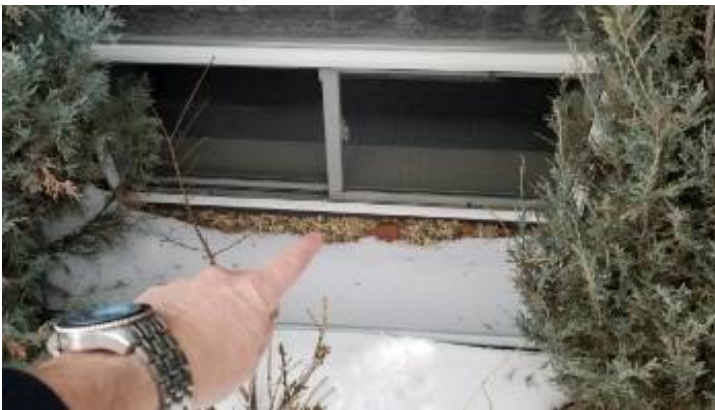
Window too close to ground.

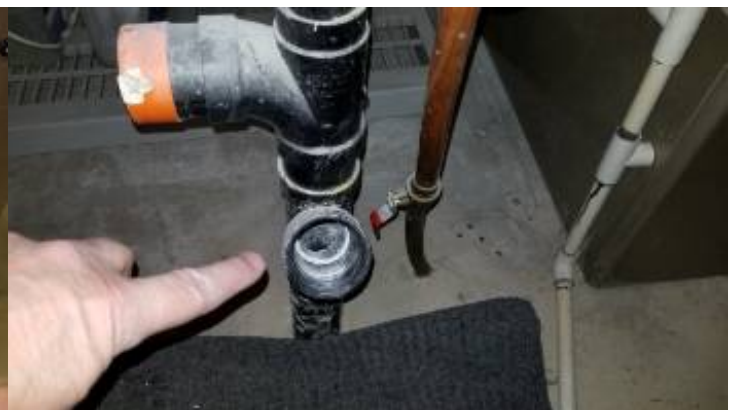
- WATER SUPPLY SYSTEM:
- Public Supply
- SHUT OFF VALVE LOCATION:
- Water meter and main water shut off valve was located furnace area.
- SHUT OFF VALVE TYPE:
- Brass ball valve
- MAIN SUPPLY LINE INTO THE HOUSE:
- Main supply line was copper
- PLUMBING DISTRIBUTION SUPPLY LINES:
- Copper
- Pex
- Black Iron
- WASTE SYSTEM:
- Public waste
- WASTE LINES:
- **ABS** Pipe
- PLUMBING CONDITIONS:
- Limited inspection due to basement finish...
- Floor drain was observed to be present...
- No floor drain cover...
- No back flow prevention valve...

Open clean out/waste line.

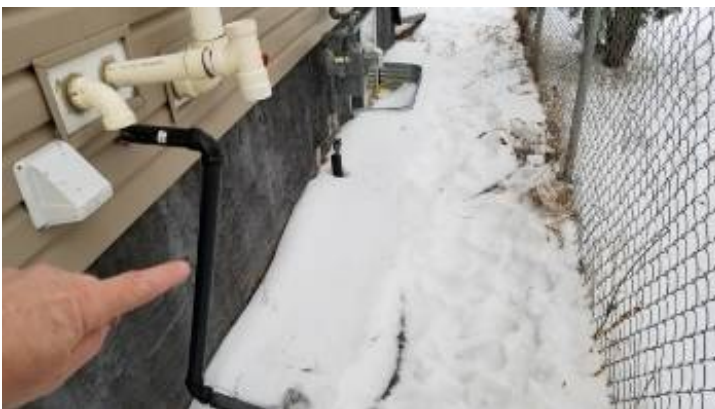
Sump discharge line.

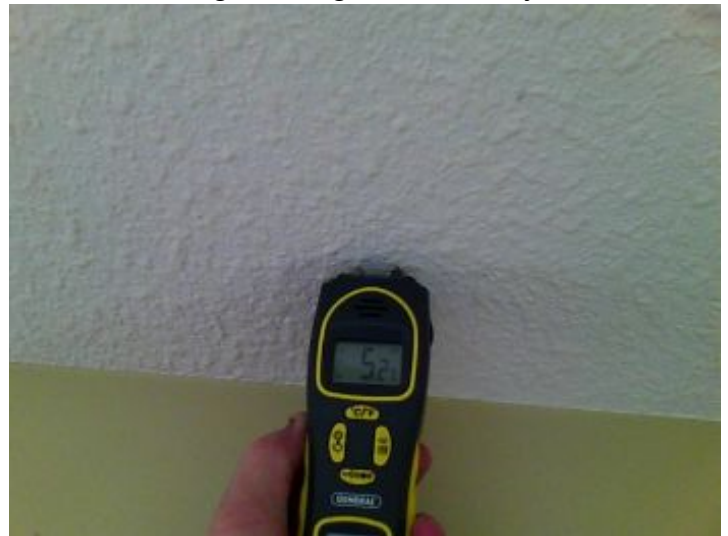
Digital image of moisture reading at anomaly.

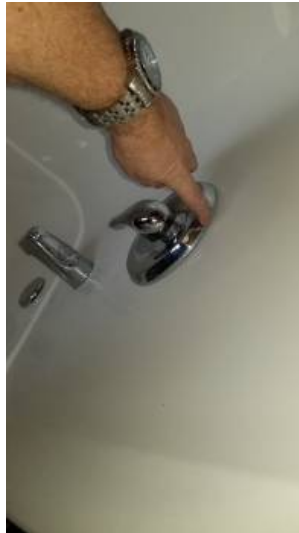
- TUB/SHOWER:
- Faucet valve escutcheon noted to be...

Loose/unsealed water valve escutcheon.

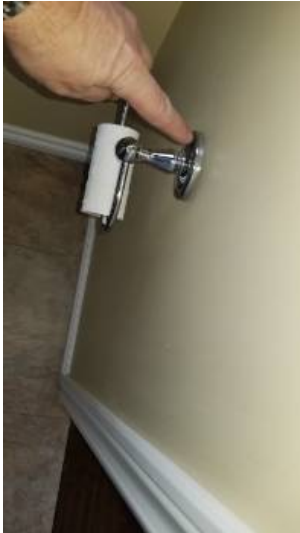
- Toilet paper holder loose/damaged...
- Towel ring noted to be missing...

Loose toilet paper holder.

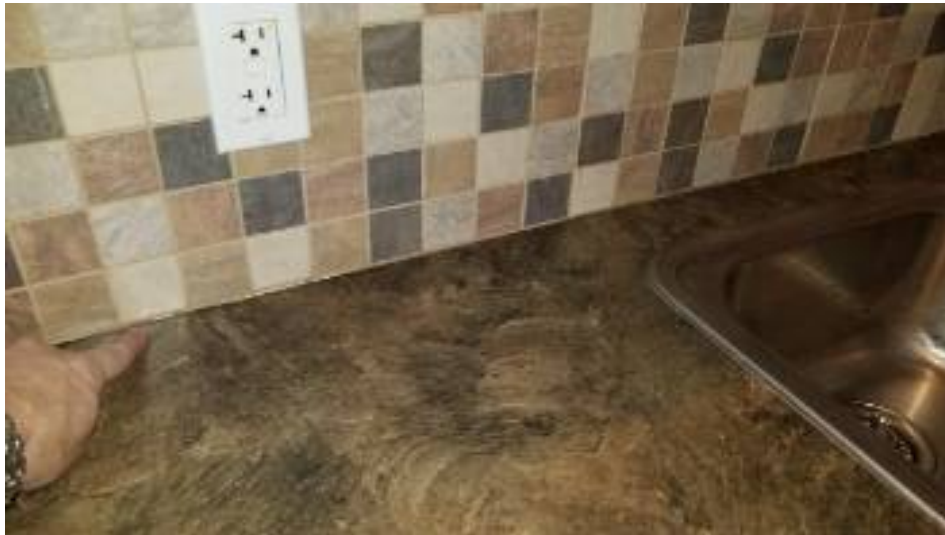
Observations:
 • CAULK:
 • Seam at wall/backsplash...

Caulk sealant required.

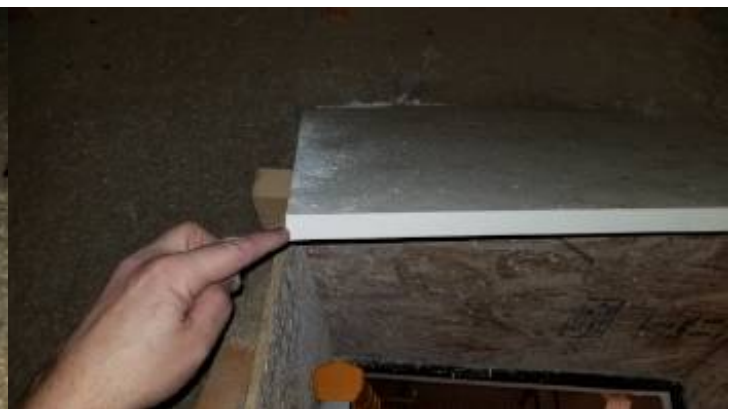
• Attic hatch cover/door was noted to be...

Insufficient hatch cover insulation.

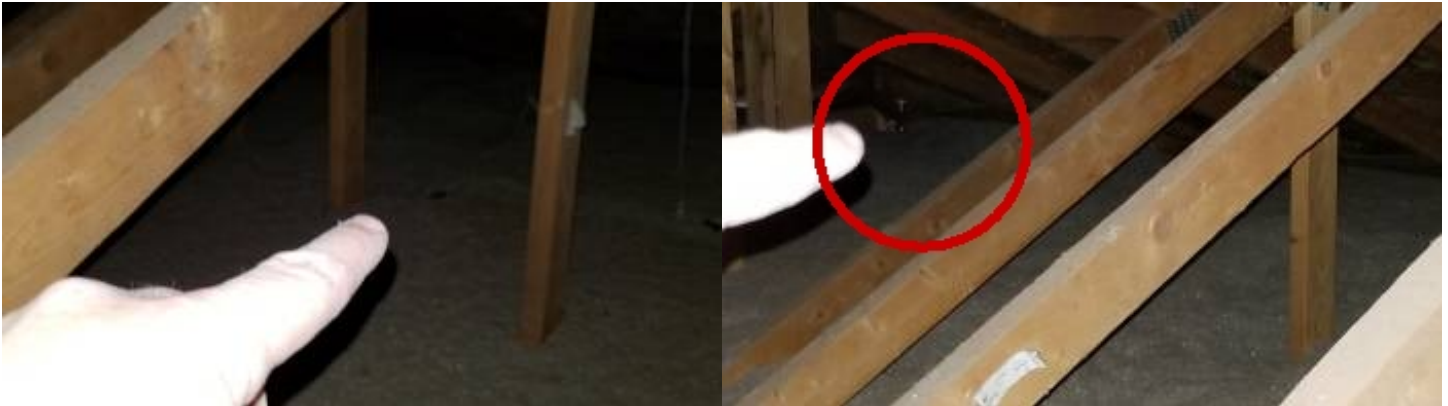
Uneven insulation coverage.
