Hanson Inspections

Your Property Inspection Report

123 Anywhere Lane, Your City, AB, M4U 1R4

Date of Inspection: 2018/4/12 Time: 9:00 AM
Age of Home: 2010 Size: 1483
Weather: Temperature approximately -4 degrees. Cloudy.
Order ID: 205

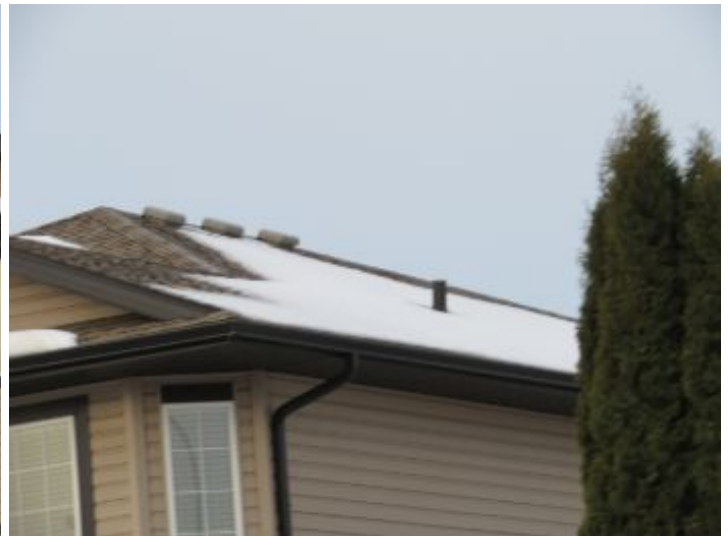
Snow/ice cover.

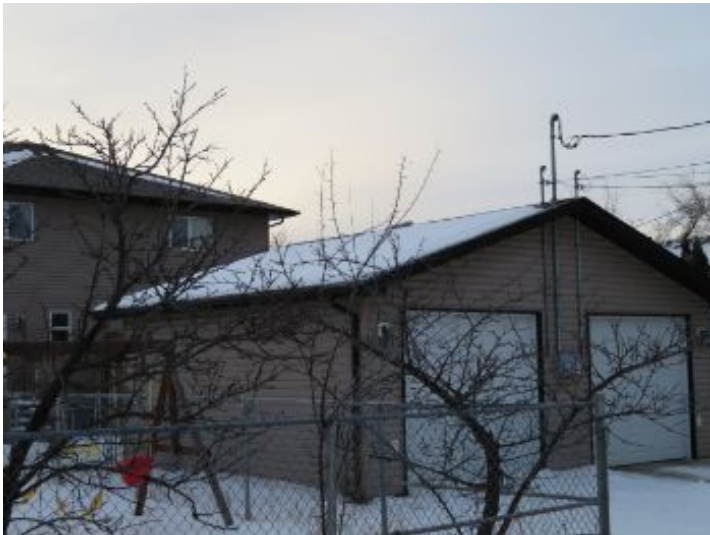
Snow/ice cover.

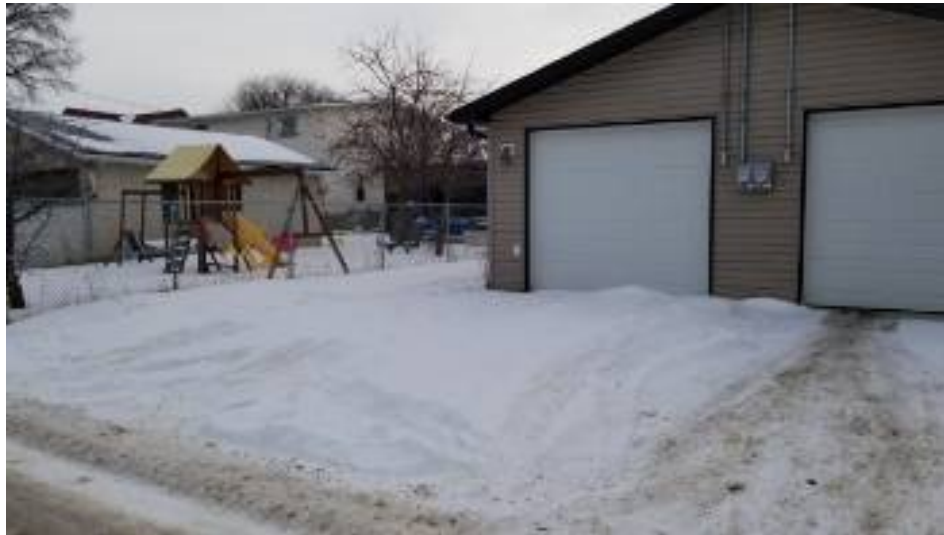
Snow/ice cover.

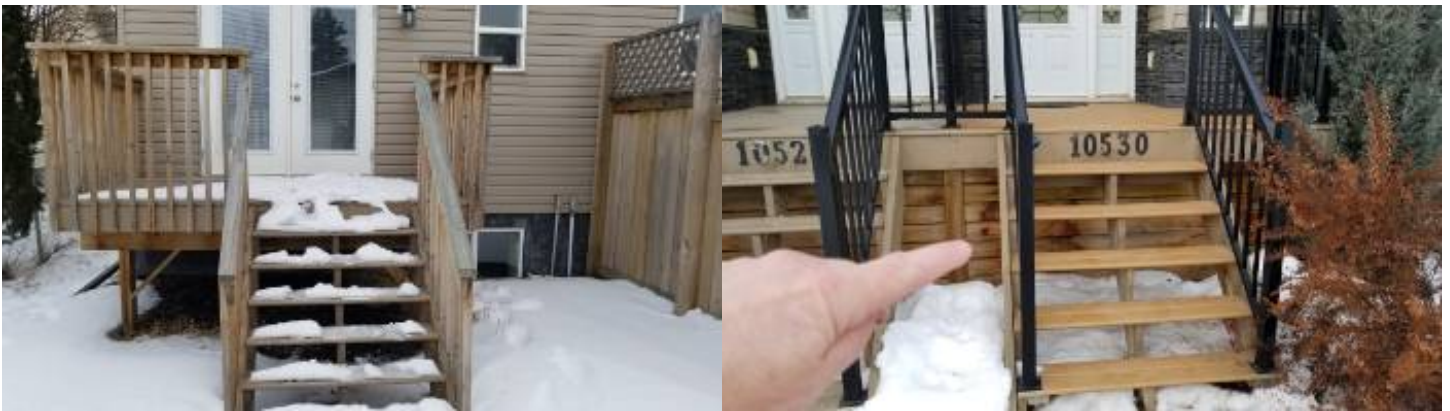
Snow/ice cover.

Limited access to structural components.

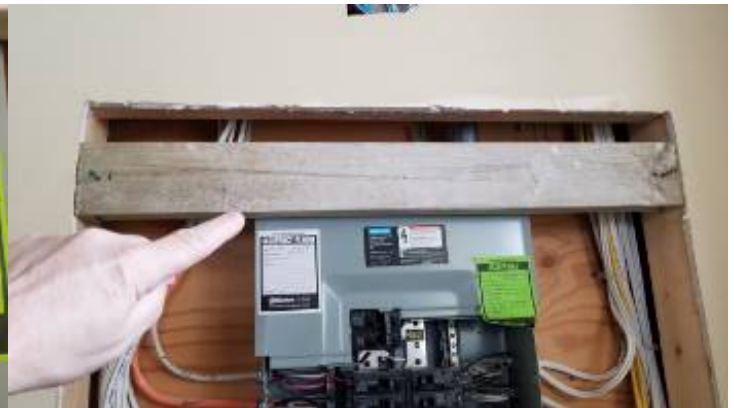
Inaccessible screws.

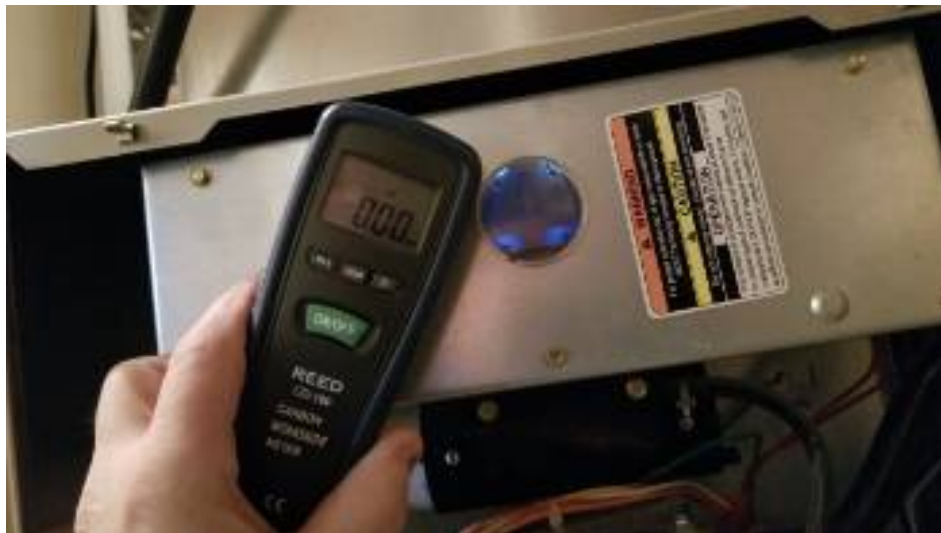
Carbon monoxide reading of 0.

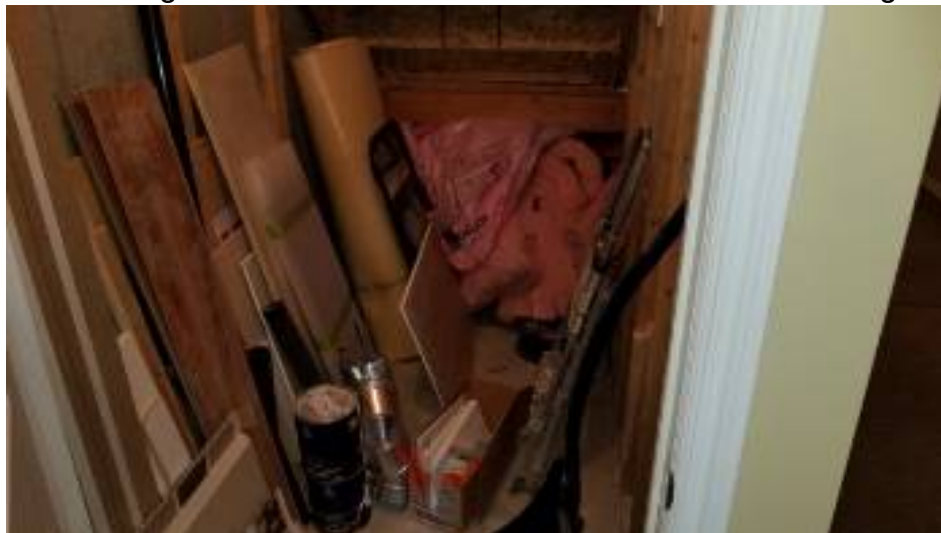
Stored material.

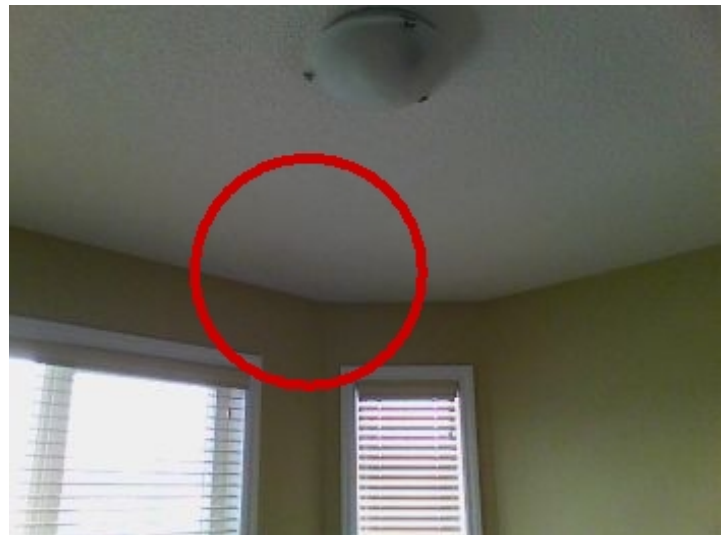
- CEILINGS/WALLS:
- Evidence of past/present water...
- Missing baseboard trim...
- The infrared thermal imaging scan indicated...
- Evidence of previous moisture intrusion...

Digital image of anomaly.

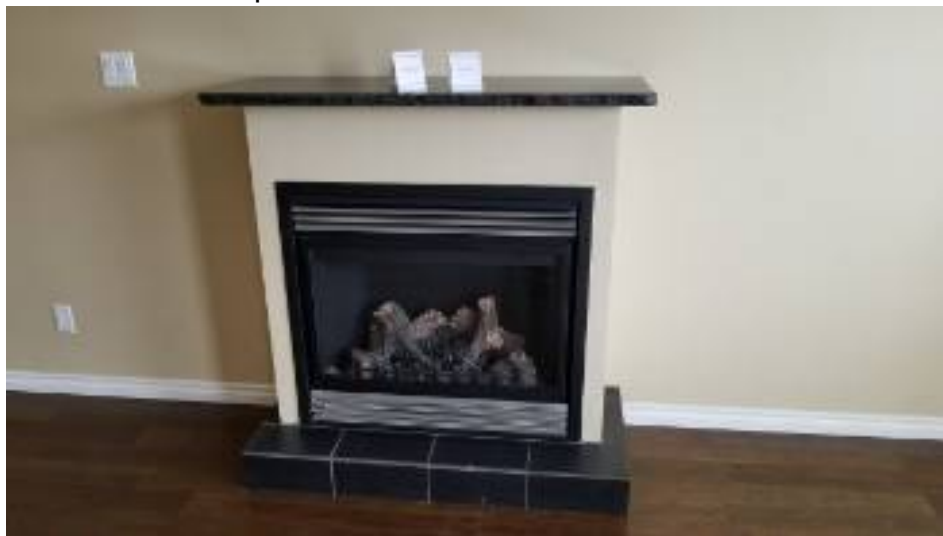
- Gas Direct vent...
- Pilot light was "off" at time of inspection...

Fireplace not operated.

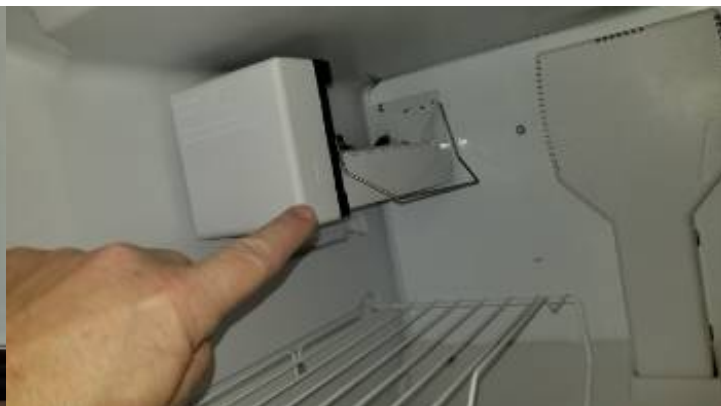
- Refrigerator was manufactured by Ikea.
- The ice maker in the fridge freezer was noted to have no tray at the time of this inspection. Recommend replacing before using.
- Range/oven combination was manufactured by Ikea.
- Cook top was electric.
- Oven was electric.
- Microwave was manufactured by Ikea.
- Range hood fan was exterior vented.

No tray for ice maker.

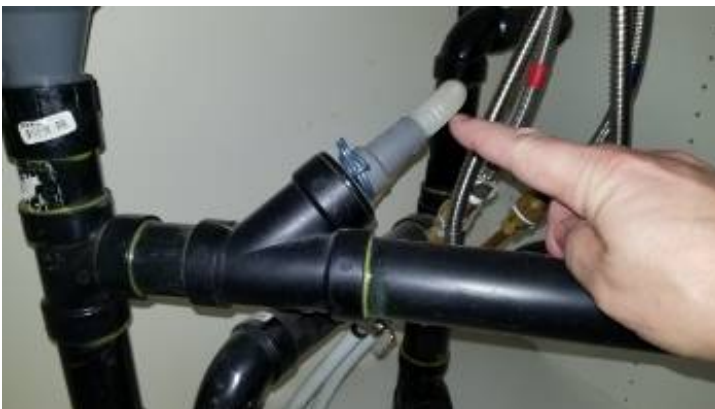
Observations:
 • No high drain loop...

No high drain loop.
